Manhole Inspection Summary

Manhole # S19Y__013MH

Insp Date: **6/3/08 10:10 AM**

Location Address: **2435 grinnalds av**

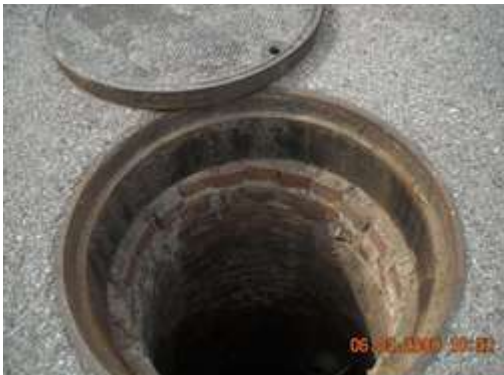
Misc. (inflow evidence)

Subject To Ponding: **Sheeting**

inflow evidence from sheeting

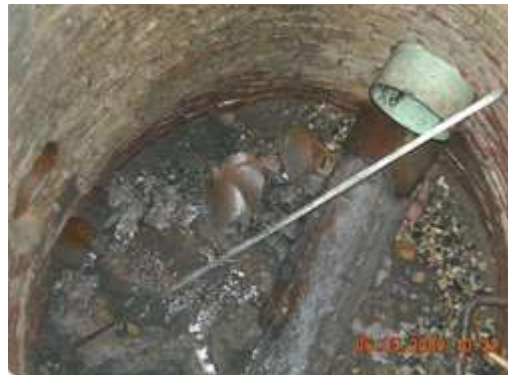
Defect 5

Condition: ☐ Sound ☐ Cracked ☐ Root Intrusion ☐ Deteriorated ☐ Leaks ☒ **Debris**

debris on bench

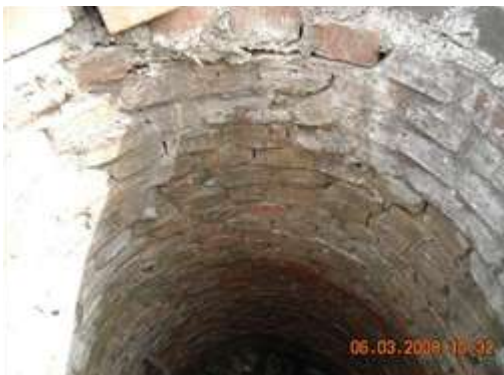
Defect 4

Infiltration: ☐ None ☐ Joint ☐ Cracks ☐ Mortar ☐ Roots ☒ **Wall**

infiltration @ corbel wall

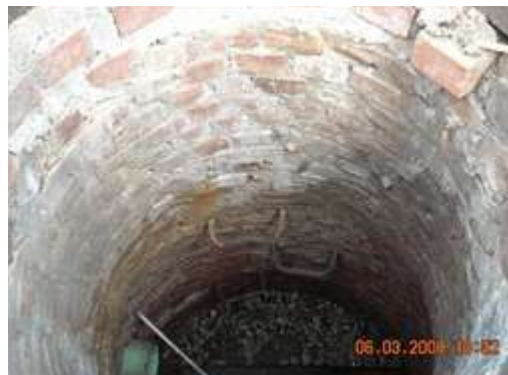
Defect 3

Count: **2** Missing: **2** ☒ **Corroded**

corroded and missing steps

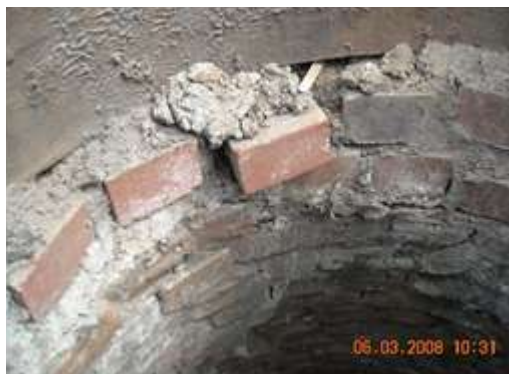
Defect 2

Condition: ☐ Sound ☐ Cracked ☐ Root Intrusion ☒ **Loose Brick** ☐ Deteriorated

loose chimney brick

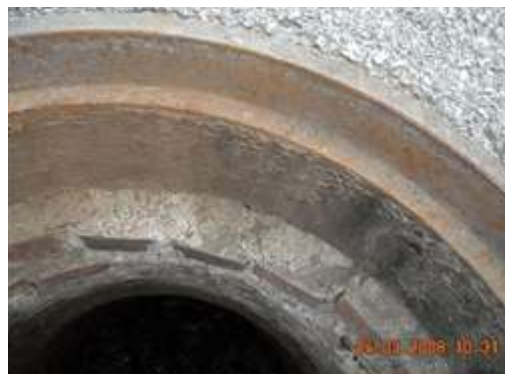
Defect 1

Offset: **1.5** (in.)

frame offset

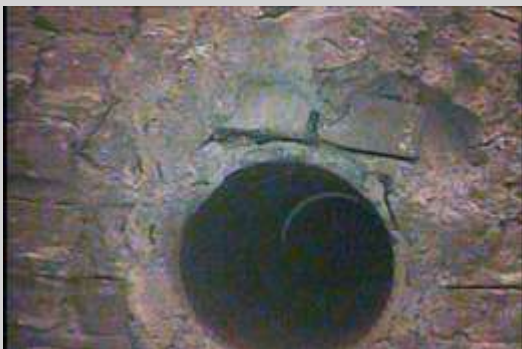
3 O'Clock Inflow

Pipe Height: **8.4** (in.) Rod and Bar (Angled)
Pipe Material: **Clay** ☐ Pipe Lined
Invert Depth: **6.62** (ft.) Flow Characteristics: **Slow**
Deposits: ☒ None ☐ Mud ☐ Sludge ☐ Debris ☐ Grease
Silt Depth: **0** (in.) Deposits Extent:
Infiltration: **None** Pipe Seal Cond: **Cracked**
